## Troubleshooting Analysis of the Cooling System in an Overheating Honda Jazz i-DSI Engine: A Case Study

This study analyzes the troubleshooting process of an overheating cooling system in a single Honda Jazz i-DSI engine used as a practical training unit at the Heavy Equipment Engineering Workshop, Politeknik Negeri Padang. A case study approach with descriptive analysis was applied through identification of overheating symptoms, inspection of cooling system components, functional testing, examination of coolant hose configuration, repair, and temperature verification. The inspection showed no blockage in the radiator, the V-belt met the inspection criteria, the thermostat opened at 80°C and fully opened at 95°C, and no mechanical damage was found in the water pump. The coolant level was low, while radiator cap pressure performance and temperature sensor accuracy were not quantitatively verified. Further inspection identified reversed inlet and outlet radiator hose installation. After correcting the hose configuration and refilling the coolant, the maximum coolant temperature decreased from 116.25°C to 95°C and subsequently decreased to 85°C. The findings indicate that incorrect

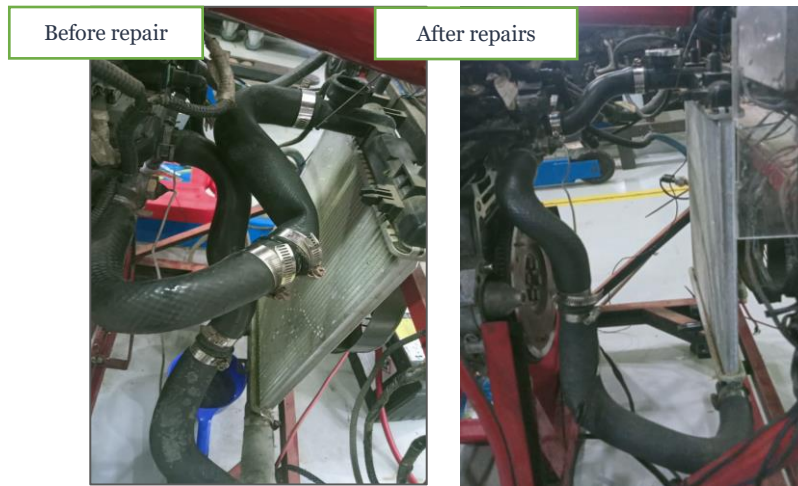
Further inspection during the assembly process identified an incorrect hose configuration at the radiator. The inlet and outlet hoses were found to be reversed from their intended installation positions. The student report also recorded that this condition resulted from a previous installation error. This finding differed from the initial visual inspection because the physical condition of the hoses showed no leakage or visible damage, whereas the problem was identified in their installation configuration. This condition indicates the importance of examining the relationships among components and the coolant circulation path in addition to inspecting the physical condition of each component.

Figure 2. Comparison of Radiator Inlet and Outlet Hose Configurations Before and After Repair

The documentation provides visual evidence of the change in hose configuration, which was one of the main findings during the troubleshooting process. The coolant was also refilled after the assembly and hose repair process. The post-repair test showed a different temperature pattern from the initial test. The coolant temperature increased from 76.25°C at the beginning of the test to 95°C, then decreased to 92.75°C and 89°C, and subsequently remained within the range of 85–88.5°C until the end of the test. The lowest temperature recorded at the end of the measurement was 85°C. These data indicate that the temperature did not continue to increase after reaching approximately 95°C, unlike the condition observed before the repair.

Further inspection found that the radiator inlet and outlet hoses had been installed in reversed positions. This condition was not identified during the initial visual inspection because the hoses showed no leakage or visible physical damage. This finding indicates that coolant passage configuration should be considered during troubleshooting when the physical condition of the components does not adequately explain the overheating symptoms[13]. Previous research on coolant passage geometry can be used to support the relationship between passage configuration and the thermal or flow characteristics of the system, while the present study demonstrates its application in troubleshooting an actual engine.

The repair was performed by returning the radiator inlet and outlet hoses to their correct configuration. The repair process was documented by comparing the conditions before and after the repair, as shown in Figure 2.

The repair was performed by returning the radiator inlet and outlet hoses to the appropriate configuration and refilling the coolant. The post-repair test showed that the coolant temperature increased to 95°C, then decreased and remained within the range of 85–88.5°C until the end of the test. This condition differed from the pre-repair test, in which the temperature increased to 116.25°C. This change is consistent with previous research showing that cooling system conditions and coolant circulation characteristics are related to engine temperature control[14]. This study contributes to the context of overheating troubleshooting by including hose configuration
