## Troubleshooting Analysis of the Cooling System in an Overheating Honda Jazz i-DSI Engine: A Case Study

This study analyzes the troubleshooting process of an overheating cooling system in a single Honda Jazz i-DSI engine used as a practical training unit at the Heavy Equipment Engineering Workshop, Politeknik Negeri Padang. A case study approach with descriptive analysis was applied through identification of overheating symptoms, inspection of cooling system components, functional testing, examination of coolant hose configuration, repair, and temperature verification. The inspection showed no blockage in the radiator, the V-belt met the inspection criteria, the thermostat opened at 80°C and fully opened at 95°C, and no mechanical damage was found in the water pump. The coolant level was low, while radiator cap pressure performance and temperature sensor accuracy were not quantitatively verified. Further inspection identified reversed inlet and outlet radiator hose installation. After correcting the hose configuration and refilling the coolant, the maximum coolant temperature decreased from 116.25°C to 95°C and subsequently decreased to 85°C. The findings indicate that incorrect

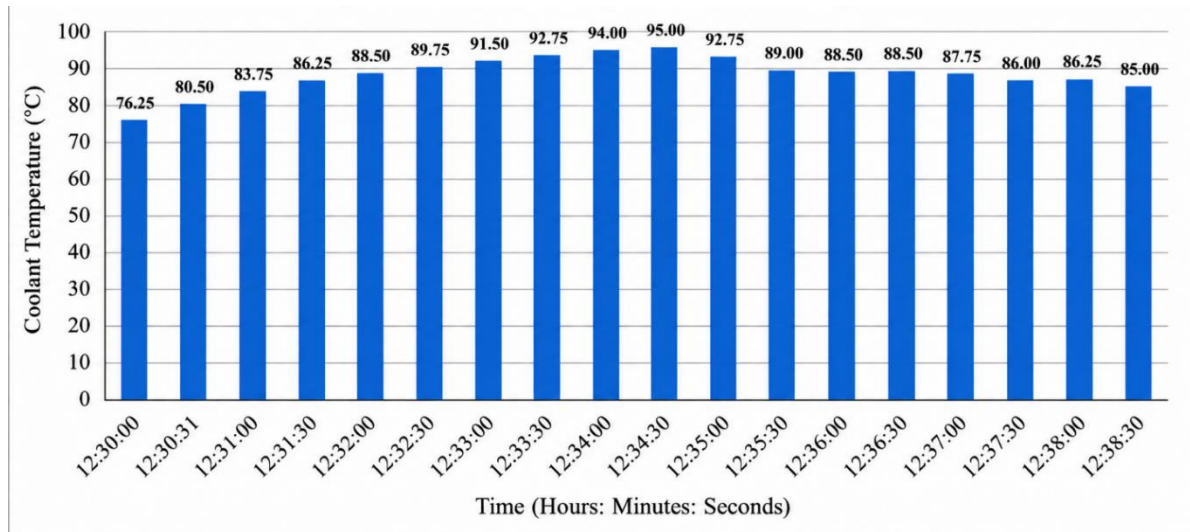
Table 5 shows that the coolant temperature gradually increased from 76.25°C at the beginning of the measurement to 95°C at 12:34:30. The temperature then decreased to 92.75°C and 89°C and subsequently remained within the range of 85–88.5°C until the end of the measurement. The temperature recorded at the end of the test was 85°C. This pattern indicates that the coolant temperature did not continue to increase after reaching approximately 95°C. The change in coolant temperature after the improvement can be seen in Figure 3.

Figure 3. Change in coolant temperature after the improvement

The post-repair verification showed that the single Honda Jazz i-DSI engine investigated exhibited a change in temperature pattern, from an increase to 116.25°C before the repair to a maximum of 95°C after the repair, followed by a decrease to 85°C at the end of the test. These results support the finding that the cooling system condition became more controlled after the corrective action. The incorrect hose configuration was a factor associated with overheating in the investigated case, while the effect of the hose configuration independently of coolant refilling could not be determined based on the available test design.
